## Investigation into the suitability of commercially available recycled glass as a blast medium

For the attention of:  
The Marine Painting Forum  
Chairman David M. Allison  
217 Trowbridge Road  
Bradford -on -Avon  
Wiltshire  
BA15 1EU

CAPCIS Ref. PE5603  
Rev 0  
January 2007

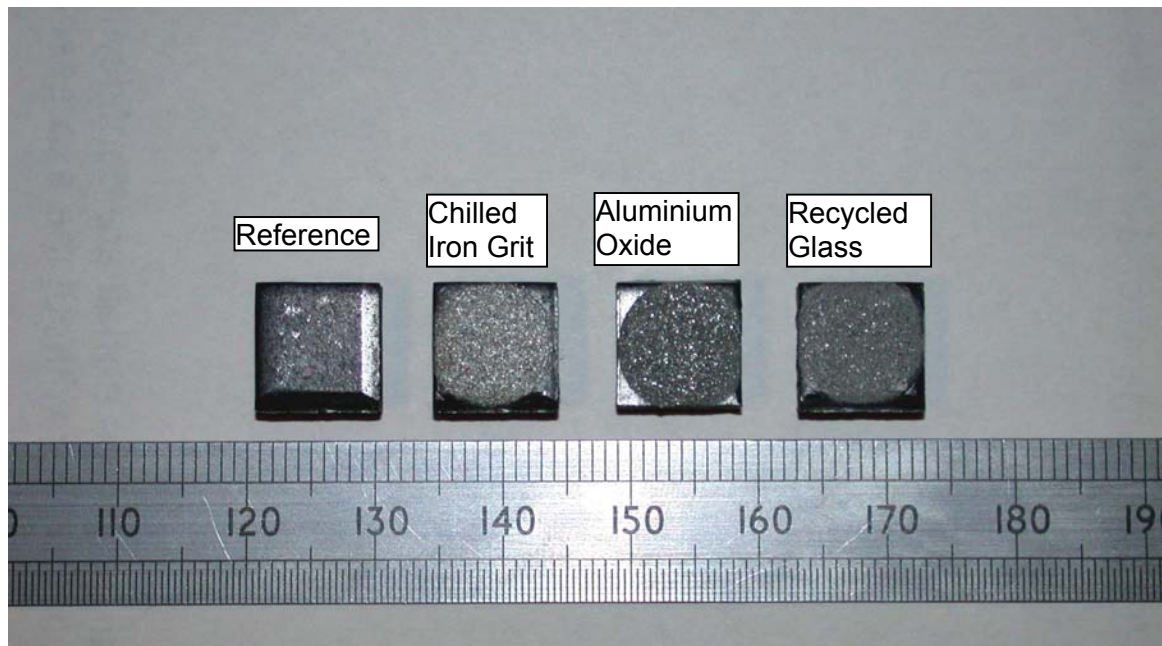
The as-received and the reference coupon showed a characteristic hot rolled surface and mill scale, A1, A2, B1, and B2.

The chilled iron grit blasted surface appeared to be rougher with an apparent large proportion of rogue peaks, A1, A3, and B3.

The aluminium oxide blasted surface appeared to be more uniform than the chilled iron grit blasted one. Of the coupons examined, the aluminium oxide blasted coupon was most lustrous, A1, A4, and B4.

The surface of the coupon blasted with recycled glass appeared non-uniform but smoother than the aluminium oxide blasted one, with a matt surface appearance, A1, A5, and B5. The edges of the blasted area were less defined, indicating areas of lower blasting efficiency, A5.

**A1: General comparison of the coupons**

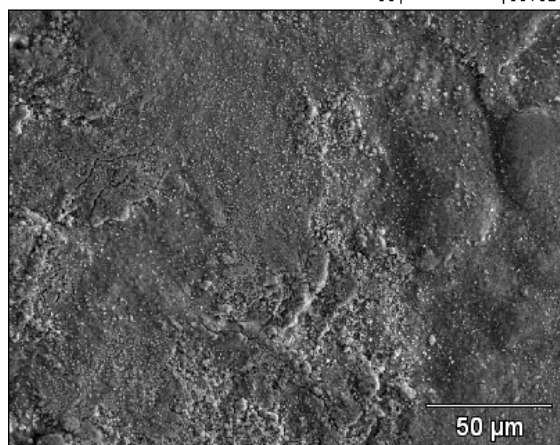
The general surface topography of the reference coupons was typical of a hot rolled steel surface, C1 to C4. EDX analysis of the surface, C5 and some particles, C6 and C7, showed elements (Fe, Mn, C) typical for mild steel and oxygen associated with an iron oxide film (mill scale). No contamination from the degreasing medium or handling (Cl peak indicative of sweat) was found.

**C1: General surface appearance  
Magnification x500**

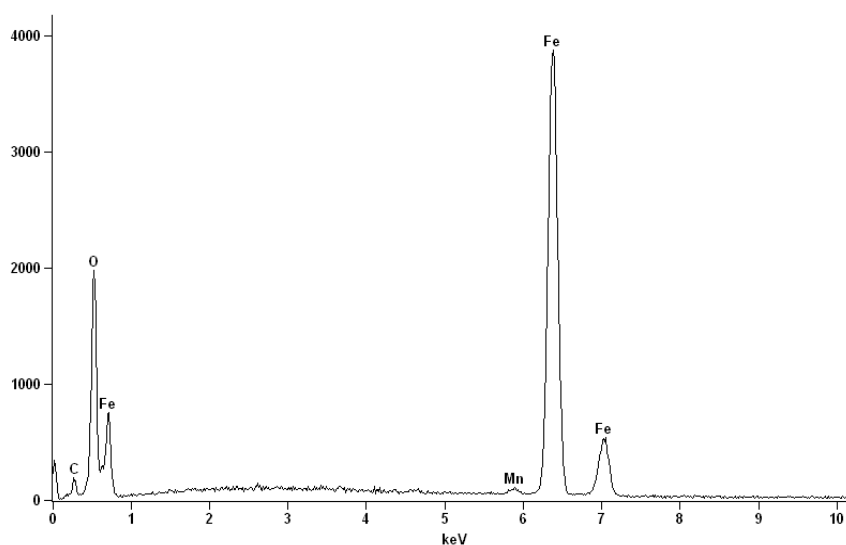
**C5: EDX Spectra of general surface**

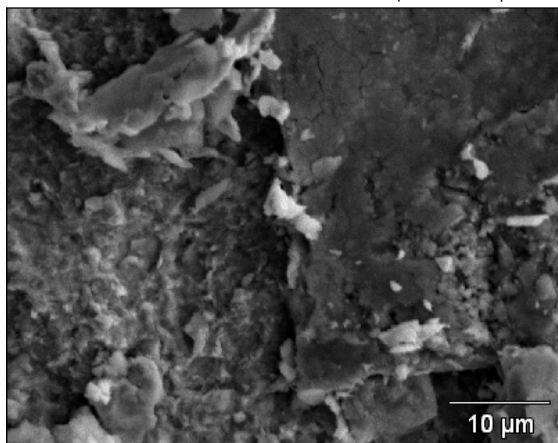
At higher magnifications, analysis of particles found on the surface indicated that they were associated with residual mill scale, D6, or contaminants within the chilled iron grit such as SiO<sub>2</sub>, Aluminium silicate, sand etc from iron slag<sup>1</sup>, D7 to D10. The absence of Cl indicates that the contamination was most likely not caused by handling.

D6: Surface at higher magnification, x2000

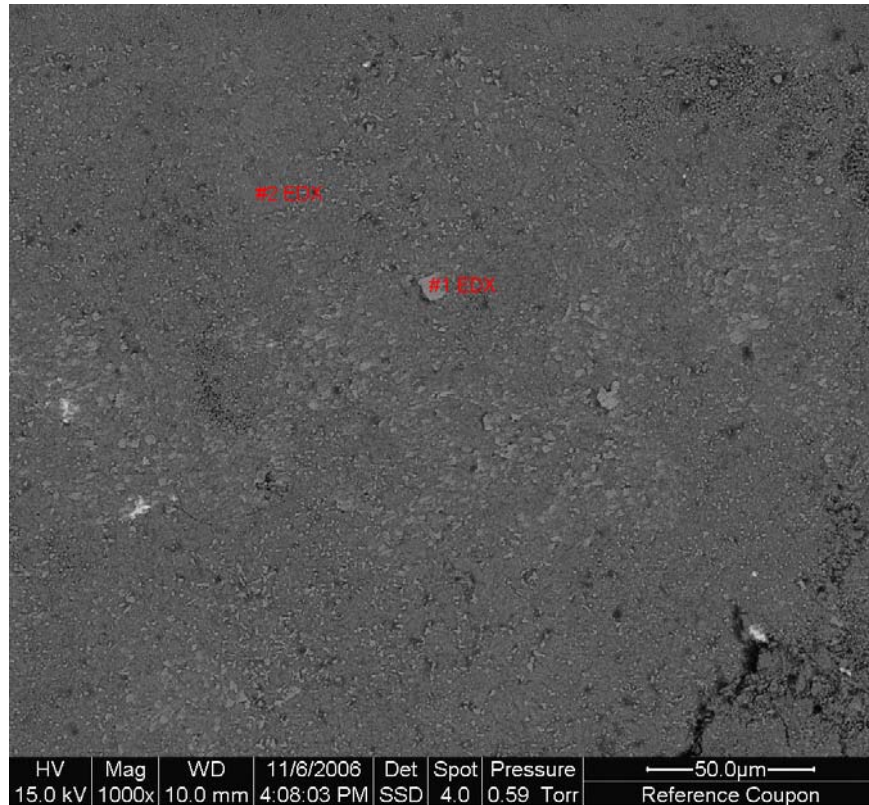
The reference coupon showed little contamination and the majority of spectra obtained of the surface and particles were associated with iron oxide from the mill scale, E4 to E6. However, a few small particles were found to contain tin, E7 and E8.

**E4: Surface at higher magnification, x1000**

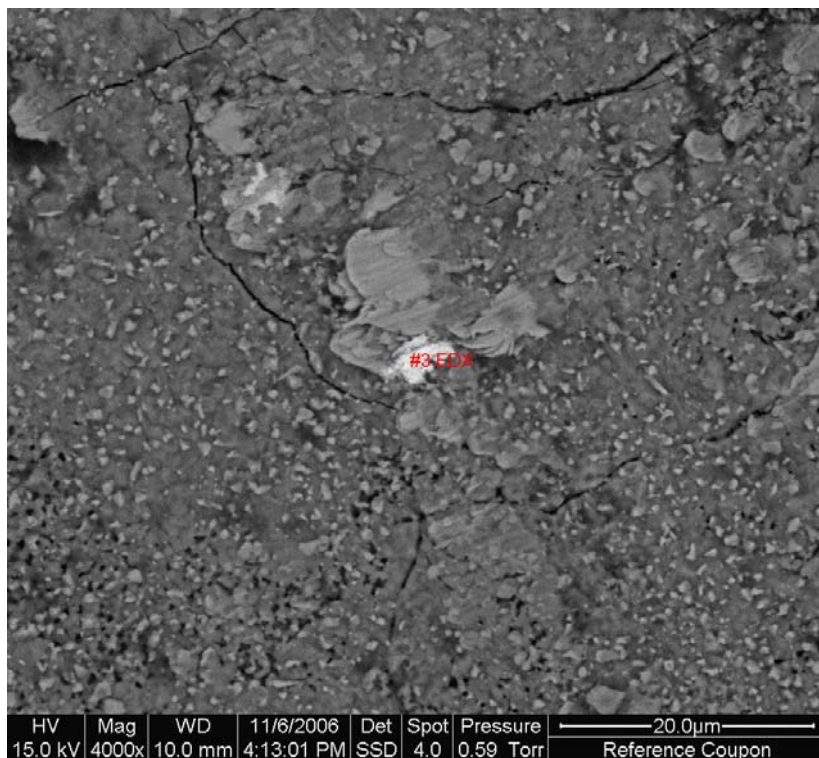
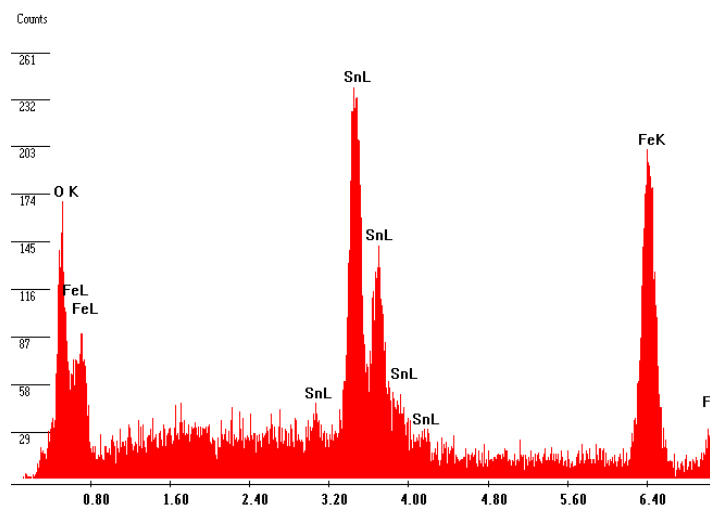
**E7: Surface at higher magnification, x4000**

Element	Wt %	At %
O	12.96	40.82
Sn	40.52	17.20
Fe	46.52	41.98

**E8: EDX analysis of particle #3**

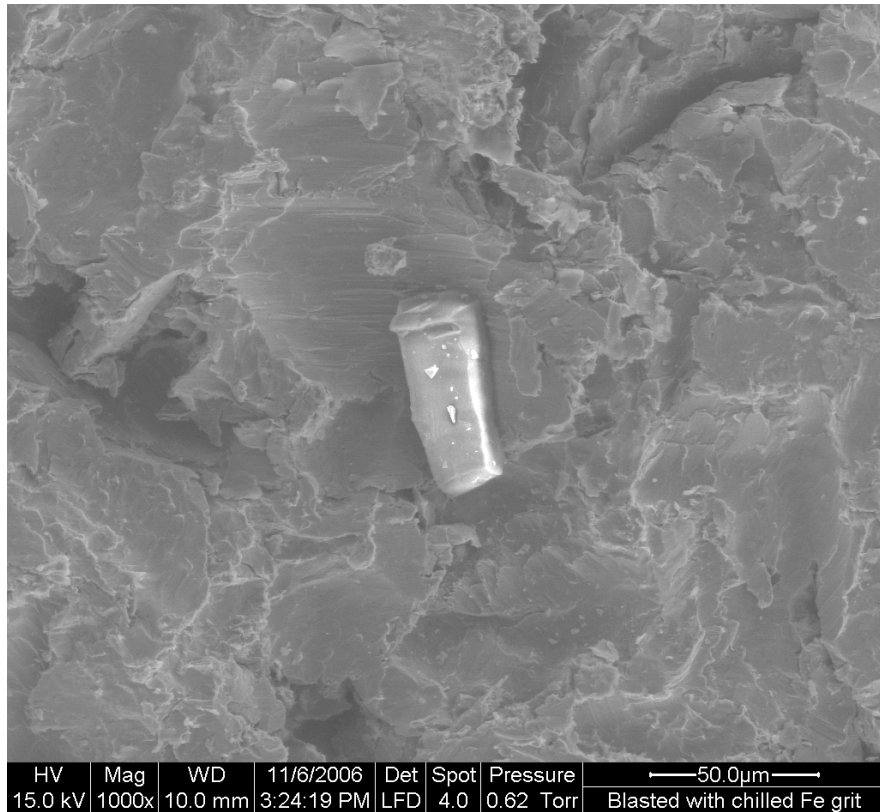
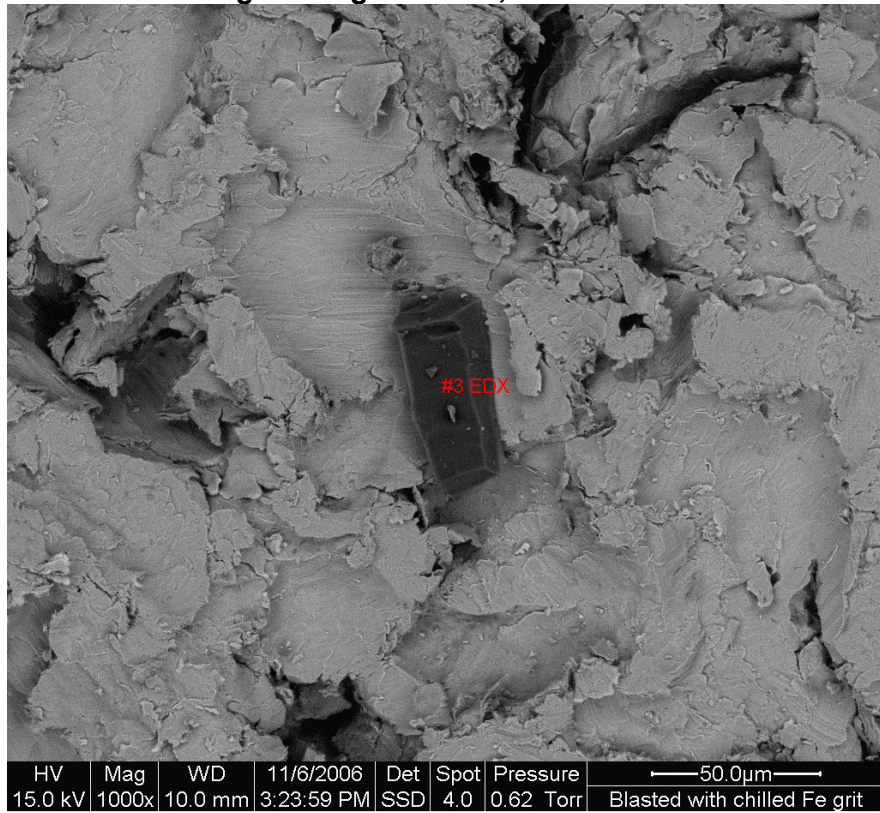
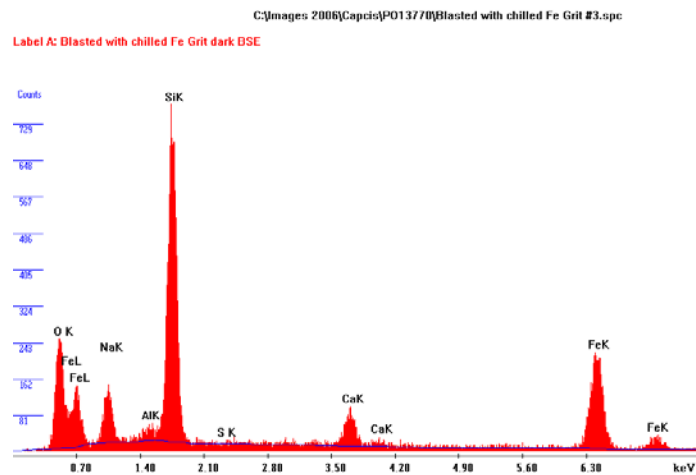
Contamination found on the coupon blasted with iron grit was mainly associated with SiO<sub>2</sub>, F7 to F9 and mill scale, F10 to F12. Some small particles were found to contain Na and Ca, F7 to F9. As no Cl peak was found, the presence of these elements is not thought to have been caused by handling and hence was most likely part of the iron grit blast media.

**F7: Surface at higher magnification, x1000**

**F8: Surface at higher magnification, x1000 (BSE)**

<i>Element</i>	<i>Wt %</i>	<i>At %</i>
<i>O</i>	13.84	27.74
<i>Na</i>	7.43	10.37
<i>Al</i>	1.34	1.59
<i>Si</i>	25.87	29.54
<i>S</i>	0.20	0.20
<i>Ca</i>	4.82	3.86
<i>Fe</i>	46.50	26.70

**F9: EDX analysis of particle #3**

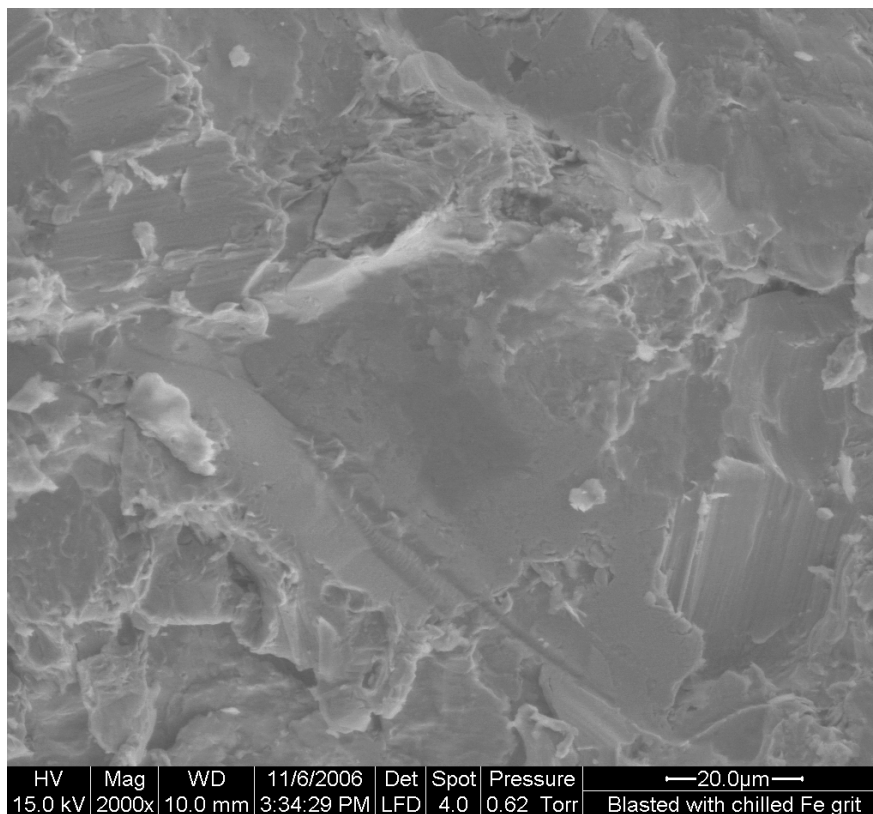
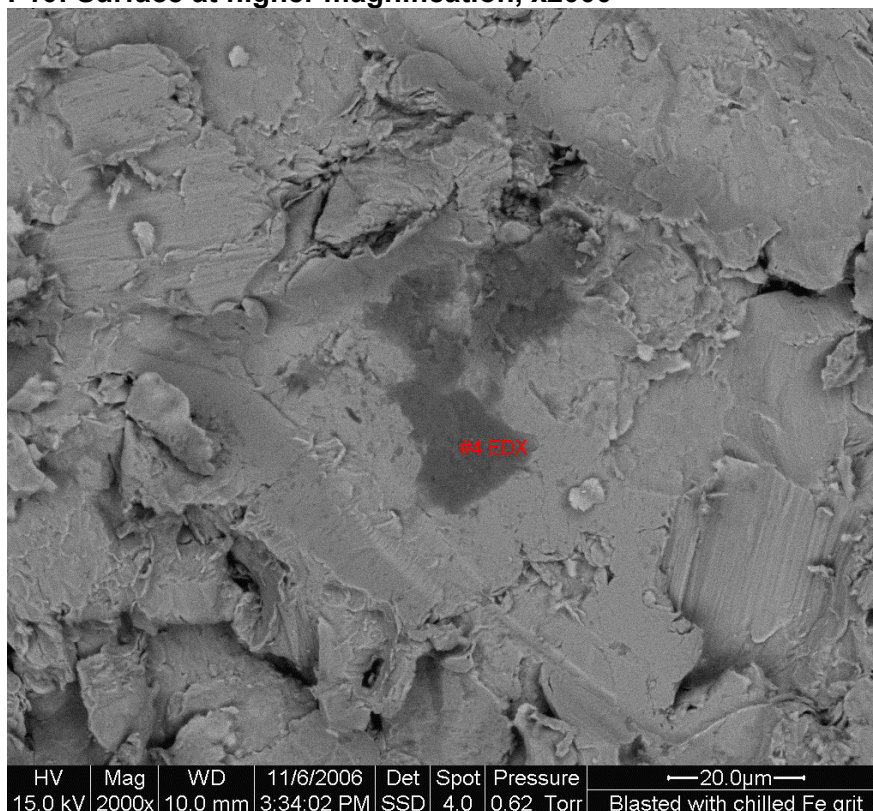
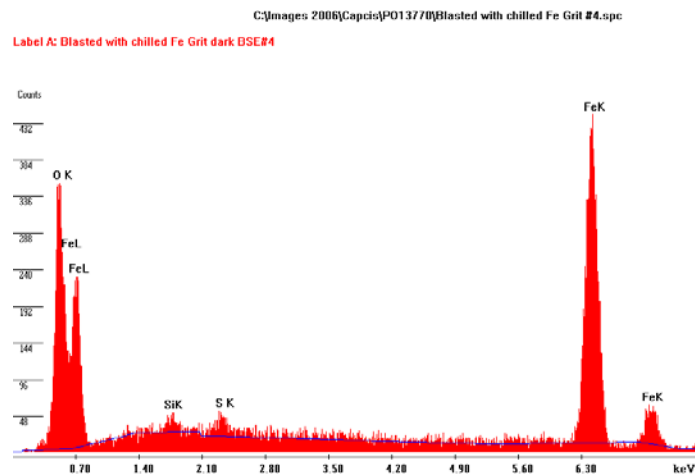
**F10: Surface at higher magnification, x2000**

**F11: Surface at higher magnification, x2000 (BSE) (stain is probably residual mill scale)**

**F12: EDX analysis of particle #4**

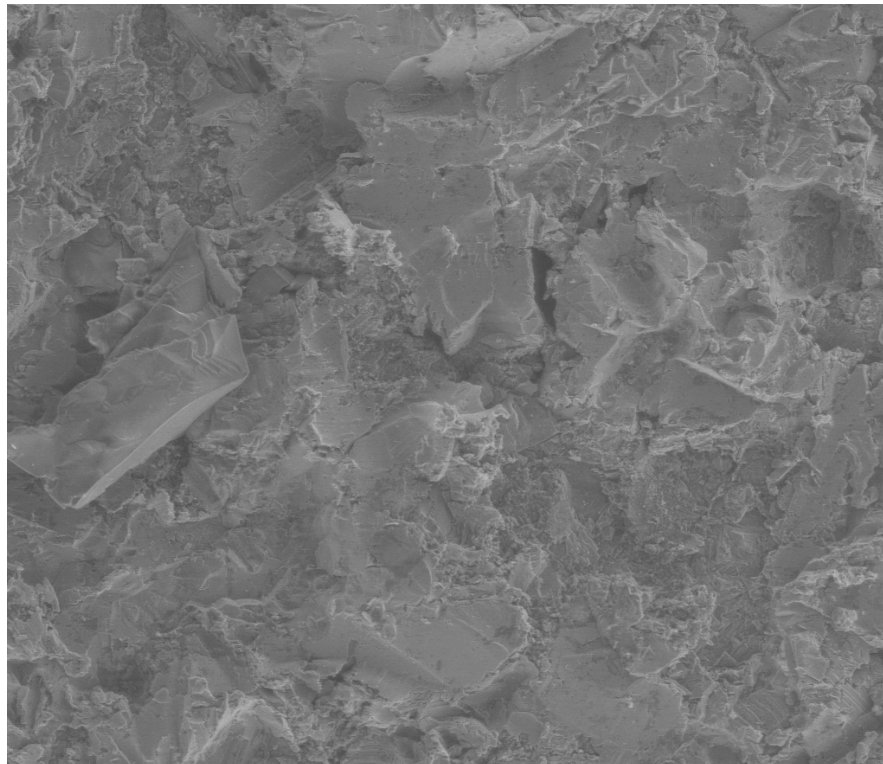
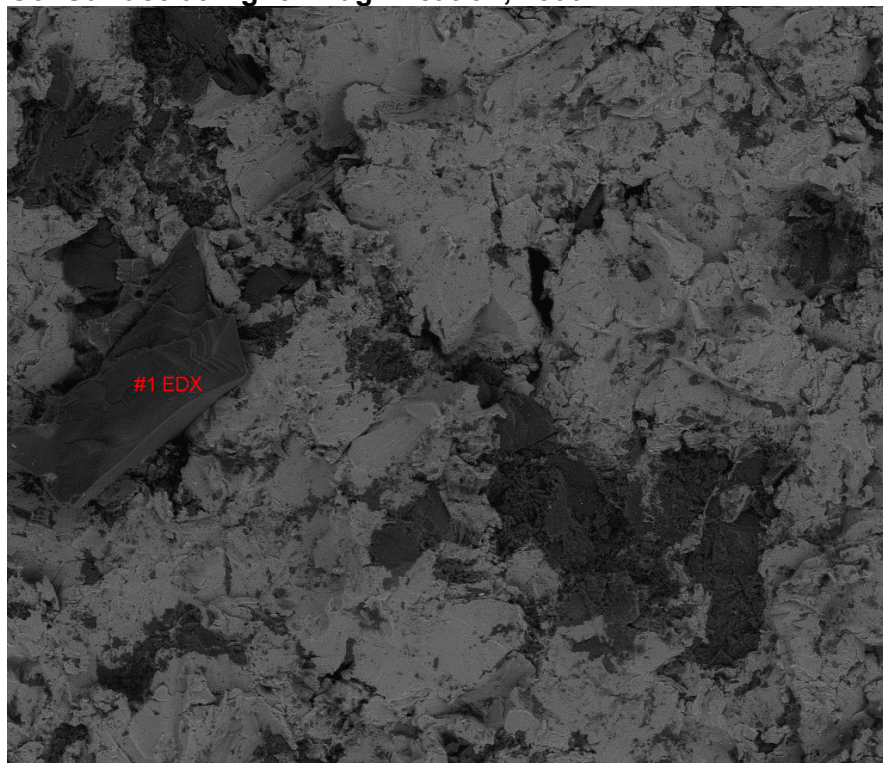
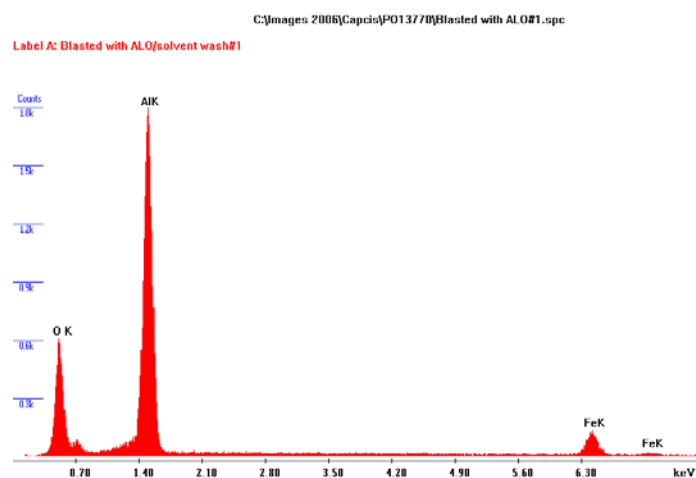
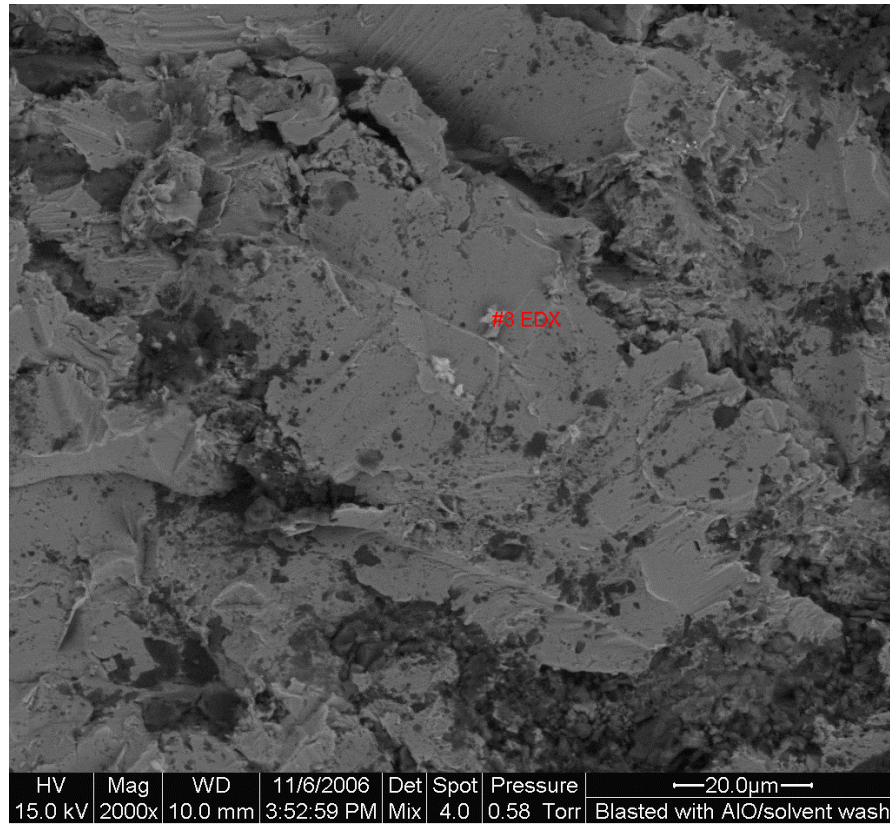
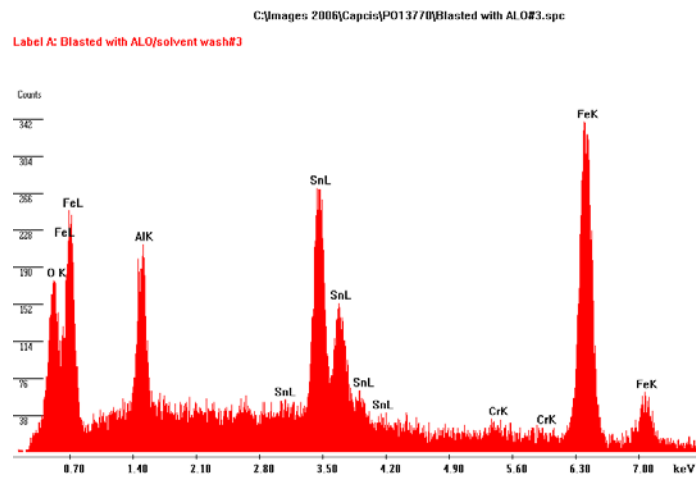
Little contamination (Sn, and Cr) was found on the coupon blasted with aluminium oxide (with solvent wash), G3 to G7, which were most likely part of the aluminium oxide blast media.

**G3: Surface at higher magnification, x500**

**G4: Surface at higher magnification, x500 (BSE)**

**G5: EDX analysis of the general surface**

**G6: Surface at higher magnification, x2000**

Element	Wt %	At %
O	9.31	28.45
Al	6.05	10.96
Sn	29.22	12.03
Cr	1.08	1.02
Fe	54.33	47.54

**G7: EDX analysis of particle #3**

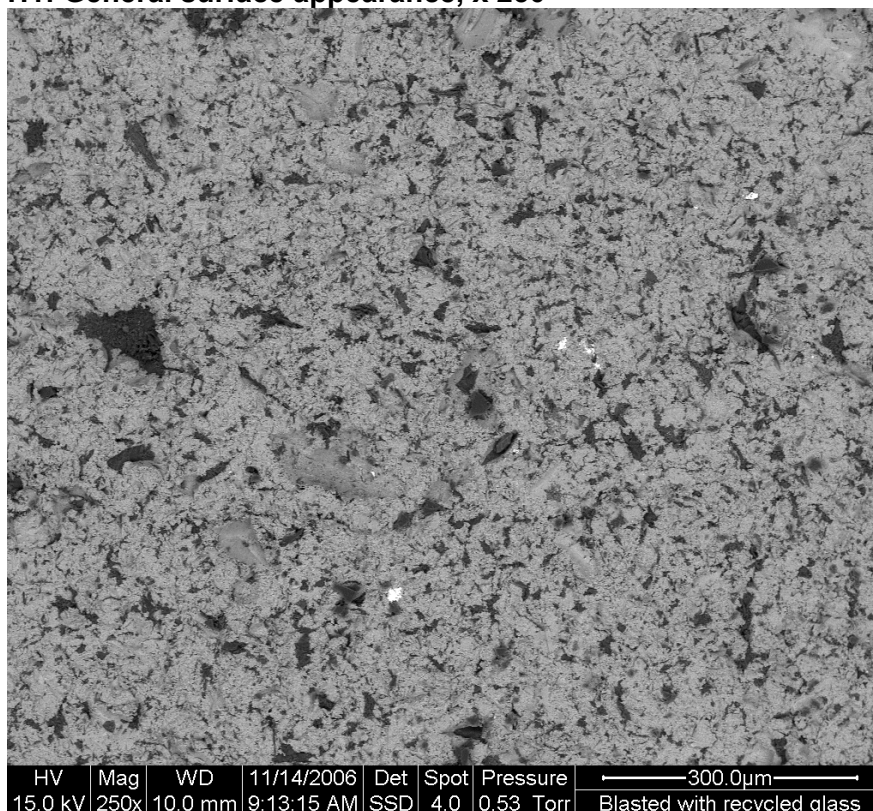
The coupons blasted with recycled glass showed the highest density of particles at the surface, H2, H4, and H11. The majority of the particulate contamination was associated with lead, H12. These lead containing particles appeared to have been deformed on impact on the surface, moulding around the surface peaks, H10. Other particles found on the surface contained Si, Na, Ca, O etc which are general constituents of glass, H6 to H8, and H13 to H15.

In comparison, the glass blasted coupons were contaminated with a large number of large and small particles (bright spots in the ESEM images). These particles contained elements present in the glass itself and lead. The lead base particles were most likely carried over from the recycling process. Even though the detection of lead was initially a surprise finding, the source of the lead can be traced back to the initial bottle/glass collection. Lead is a known contaminant of recycled glass, as are aluminium, brass, and stainless steel from bottle lids and caps.

**H2: General surface appearance, x 250 (BSE) (White spots are lead based particles)**

- Achievable surface profile and blast efficiency – This may include blasting parameters / conditions.
- Effect of lead or other contaminants (if any) on the performance of applied coatings such as adhesion, corrosion resistance etc.
- Different sources of recycled glass including characterisation of glass (contamination levels and type) to ensure consistent results.

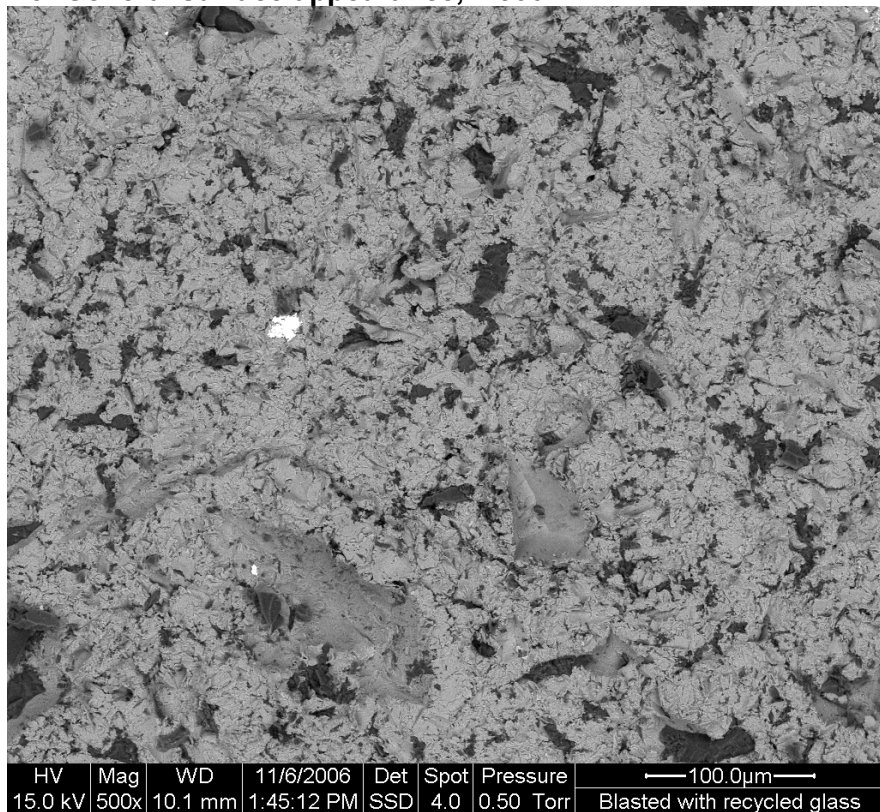
**H4: General surface appearance, x 500 (BSE)**

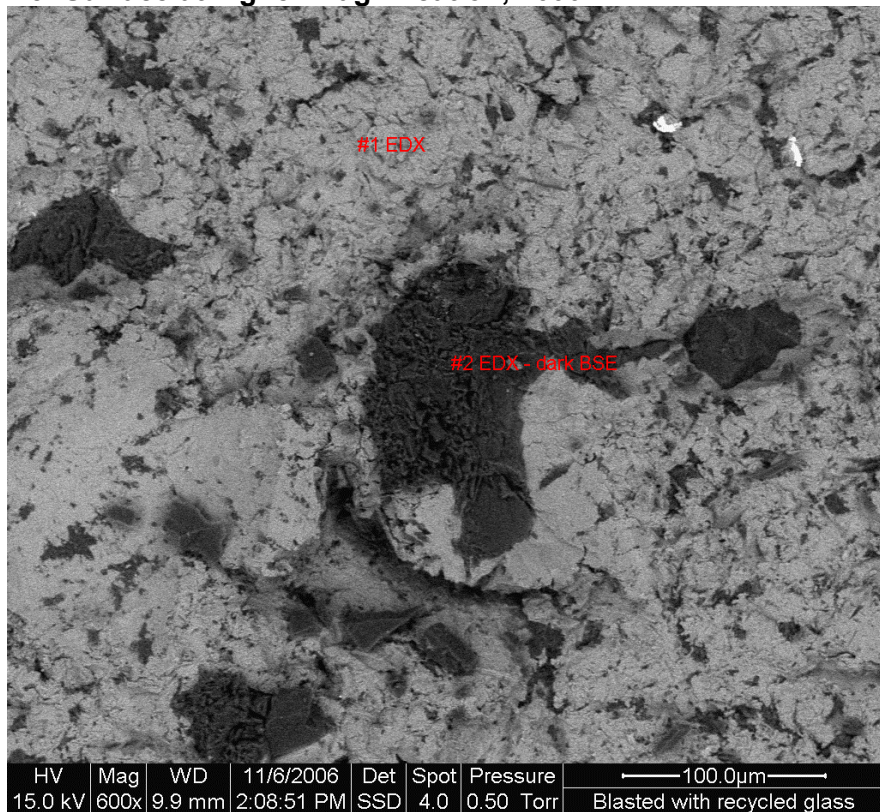
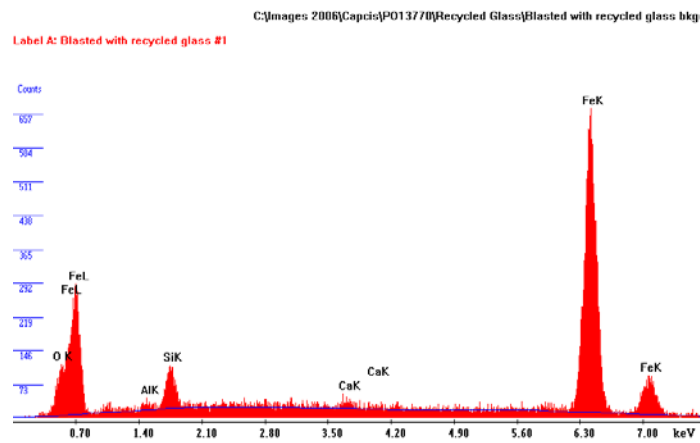
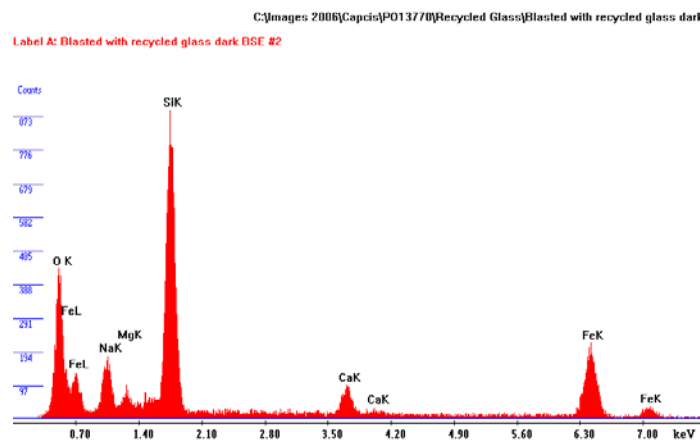
**H6: Surface at higher magnification, x600 (BSE)**

## H7: EDX analysis of the general surface

## H8: EDX analysis of particle #2

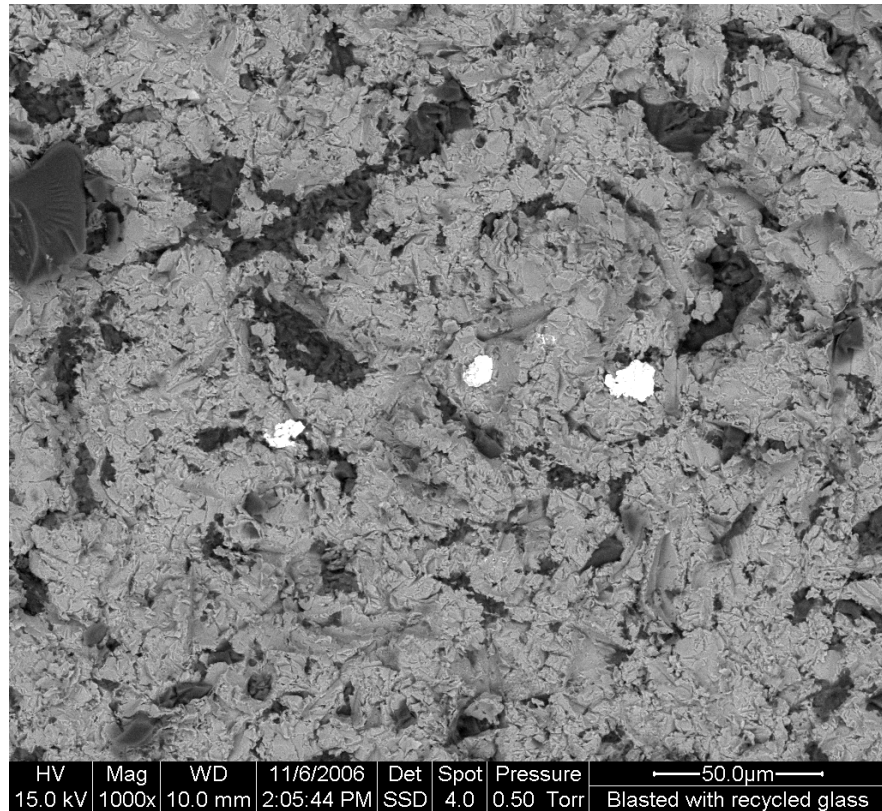
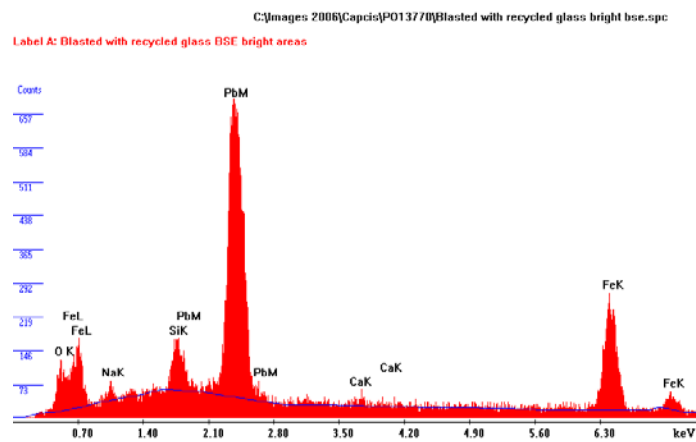
**H11: Surface at higher magnification, x1000 (BSE)**

Element	Wt %	At %
O	5.19	23.90
Na	1.18	3.80
Mg	0.47	1.43
Si	2.53	6.63
Pb	57.89	20.59
Ca	0.86	1.59
Fe	31.87	42.06

**H12: EDX analysis of bright particle**

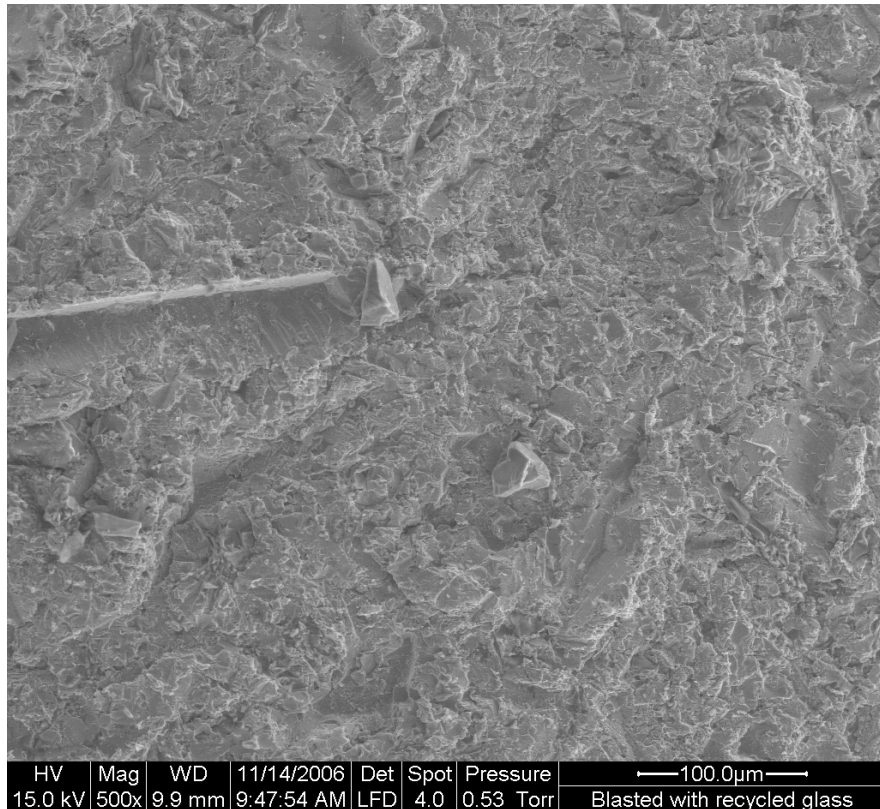
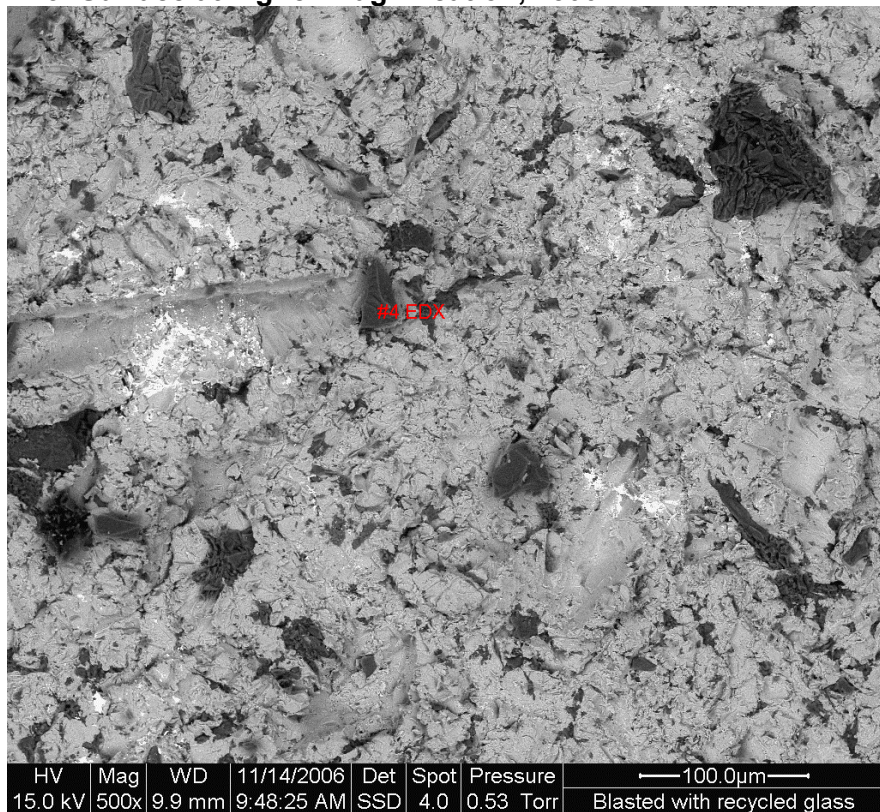
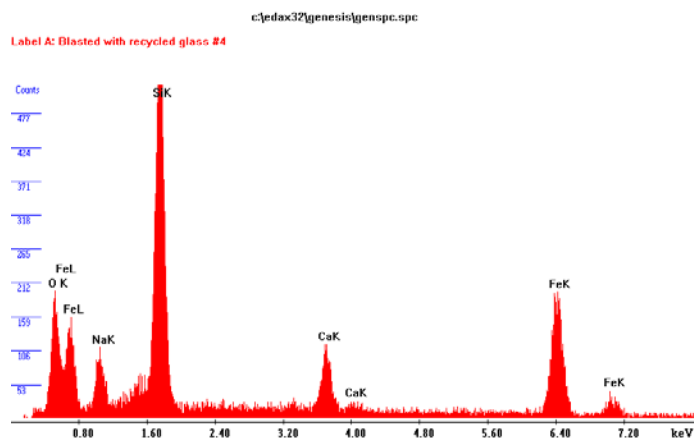
**H13: Surface at higher magnification, x500**

**H14: Surface at higher magnification, x500 (BSE)**

**H15: EDX analysis of particle #4**

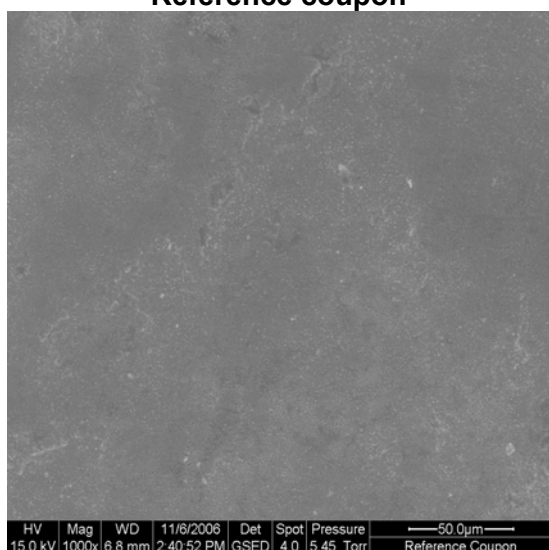
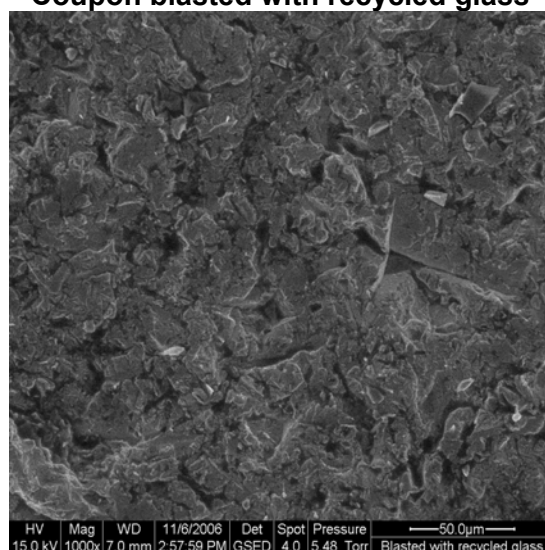
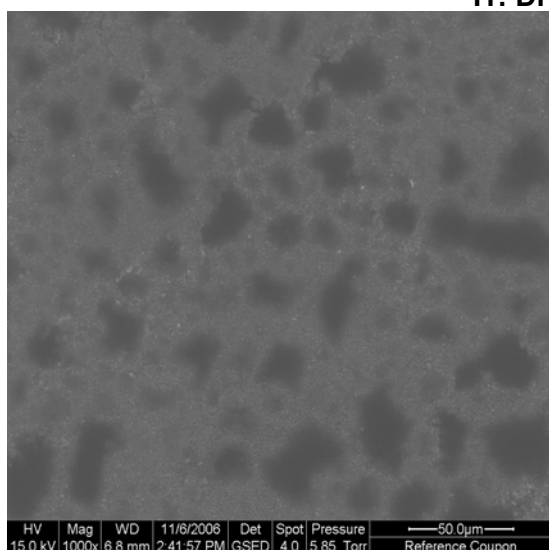
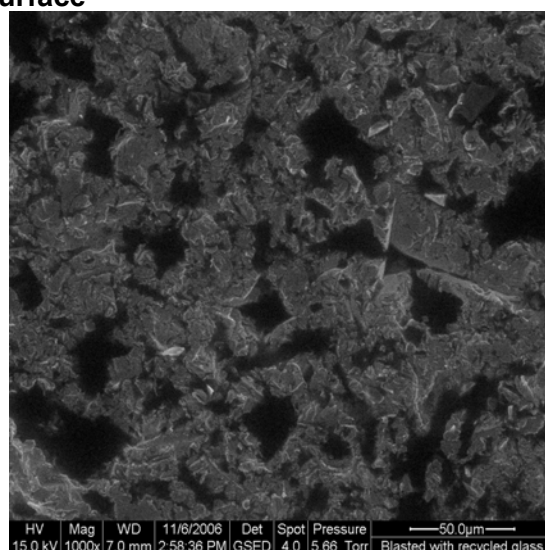
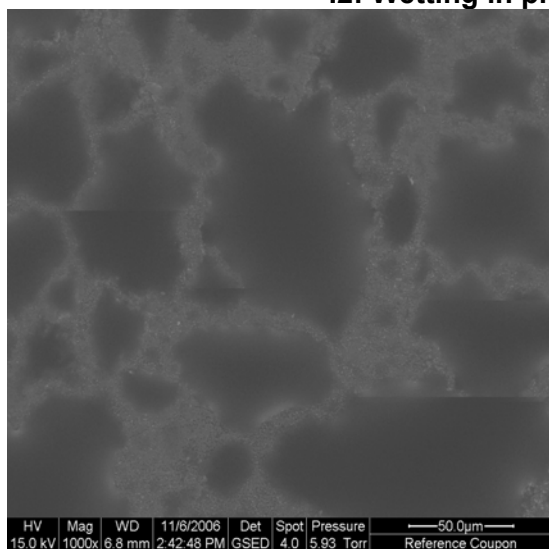
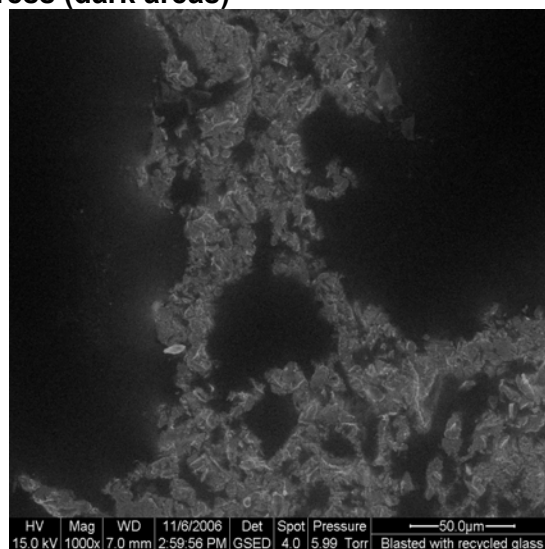
The ESEM images, I1 to I3 in Appendix I show the wetting process and effect on the coupon blasted with recycled glass and the reference coupon. Initial wetting of the surfaces, I2, resulted in the formation of small puddles/droplets at discrete sites. For the glass blasted coupon, these initiation sites are located within the valleys of the blasted surface. Wetting the surfaces further led to an increase in puddle/droplet size which eventually joined to flood the surface. No real differences, and more importantly, no water repellent effects were observed on the glass blasted coupon.

I1: Dry surface

I2: Wetting in progress (dark areas)

I3: Specimens partly flooded

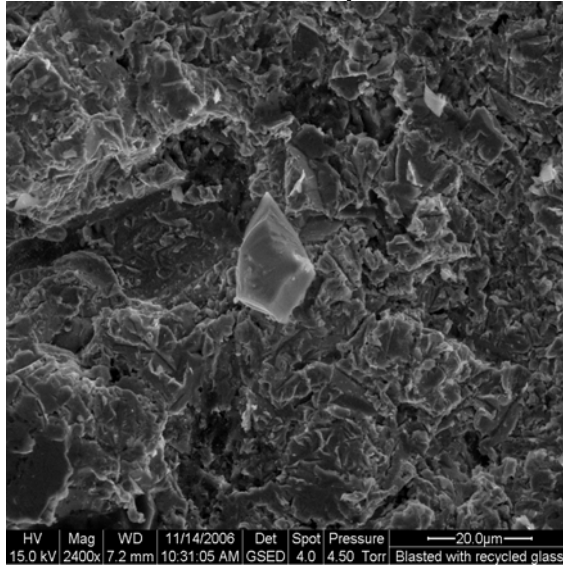
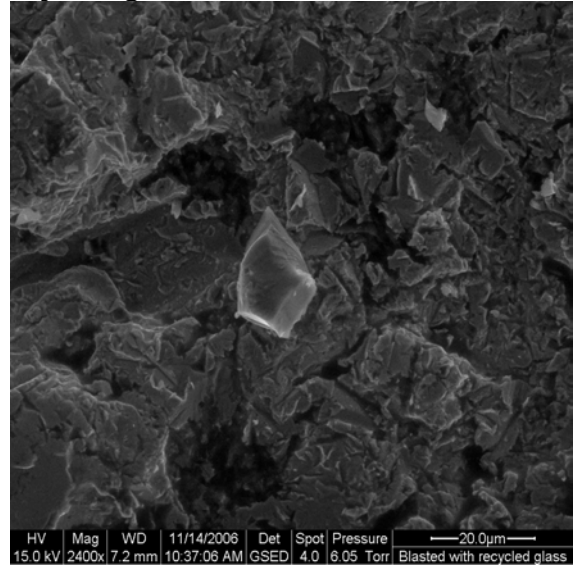
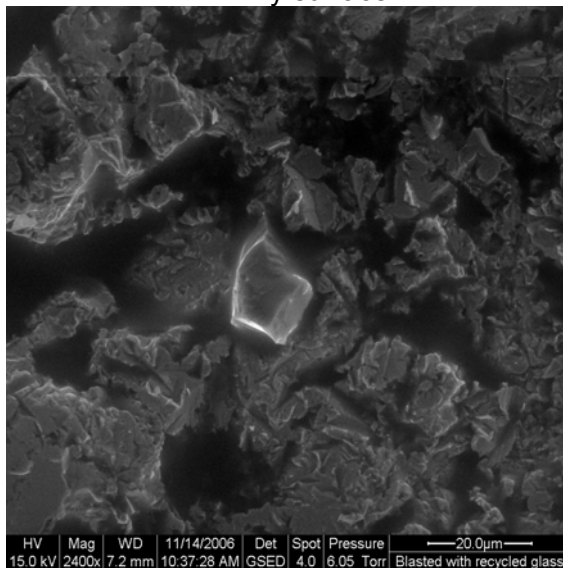
## **I4: Wetting characteristics around a particle**

The wetting process around a particle, which may have been a site for oil contamination has also been investigated, I4. Again, no water-repellent effects were observed and the coupon's surface appears to flood through the channels and valleys present in the surface roughness.
